## **Geology to unplanned construction: Decoding why Joshimath is sinking**

*Hindustan Times, 7 January 2023*

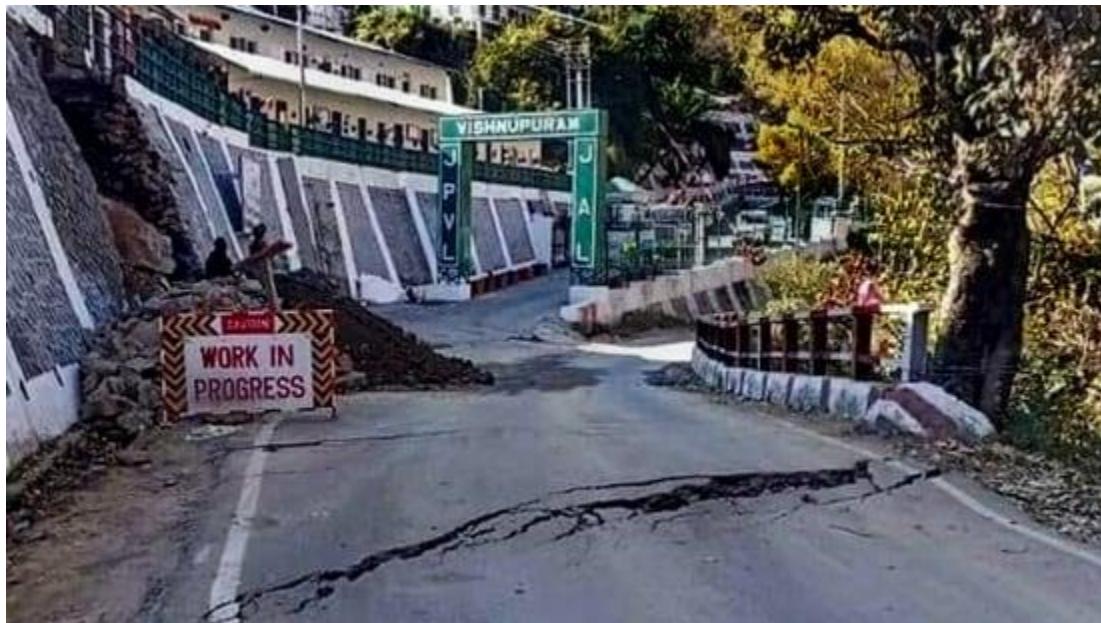
Cracks appear in the houses and on the roads due to landslides at the Joshimath of Chamoli district of Uttarakhand. (PTI)
